TITLE OF THESIS Bank Erosion in the Southern Mackenzie
River Delta, Northwest Territories, Canada

BANK EROSION IN THE SOUTHERN MACKENZIE RIVER DELTA,
NORTHWEST TERRITORIES, CANADA

A THESIS

DEPARTMENT OF GEOGRAPHY

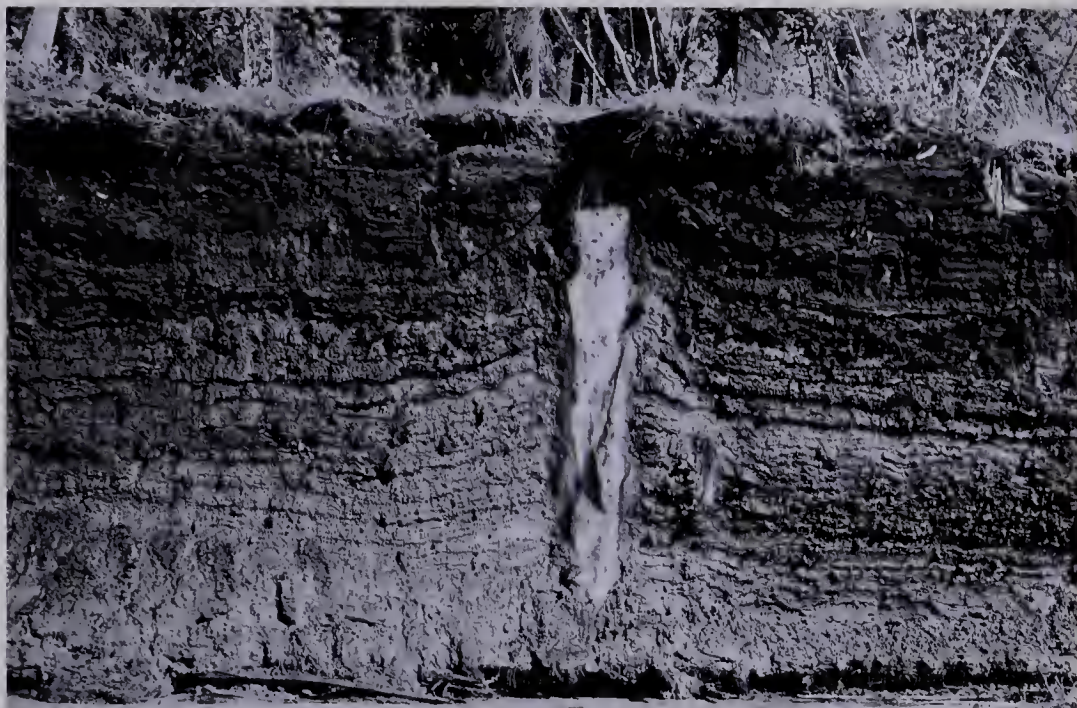
Plate 1 An ice wedge in a bank with ice-rich sediment. Alluvium layers have been upturned by its formation.

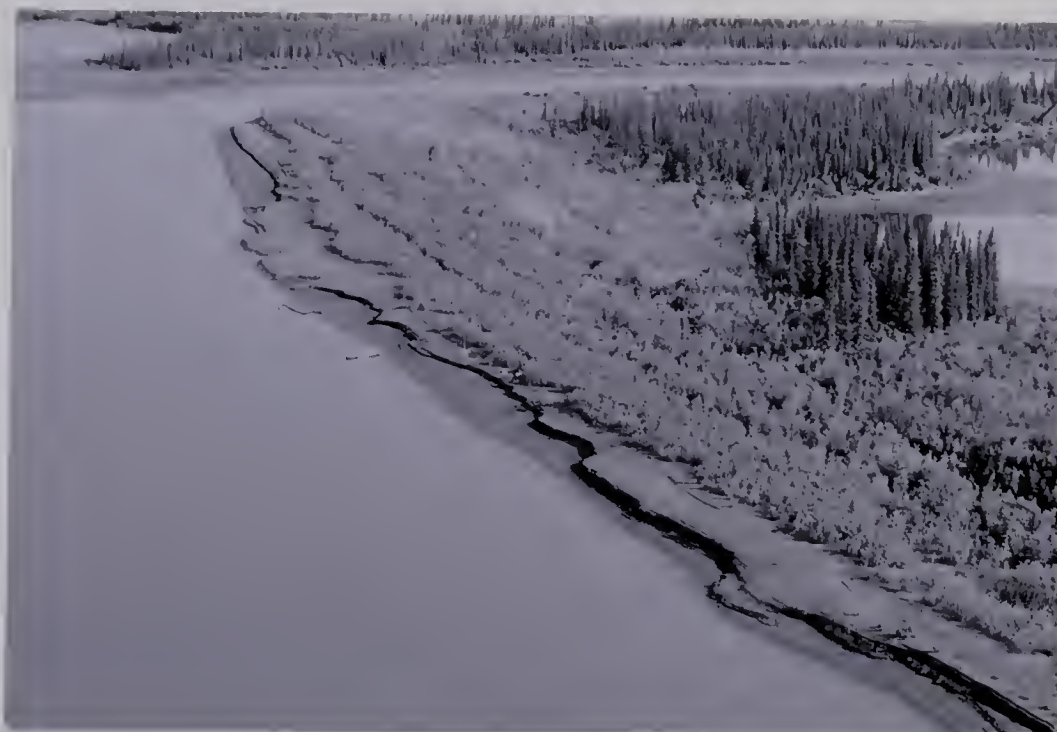
Plate 3 A point-bar near Reindeer Station eroded by strandline erosion (by permission, Don Gill).

Strandline erosion is found only on banks with shape 5 or on point-bars (Plate 3).

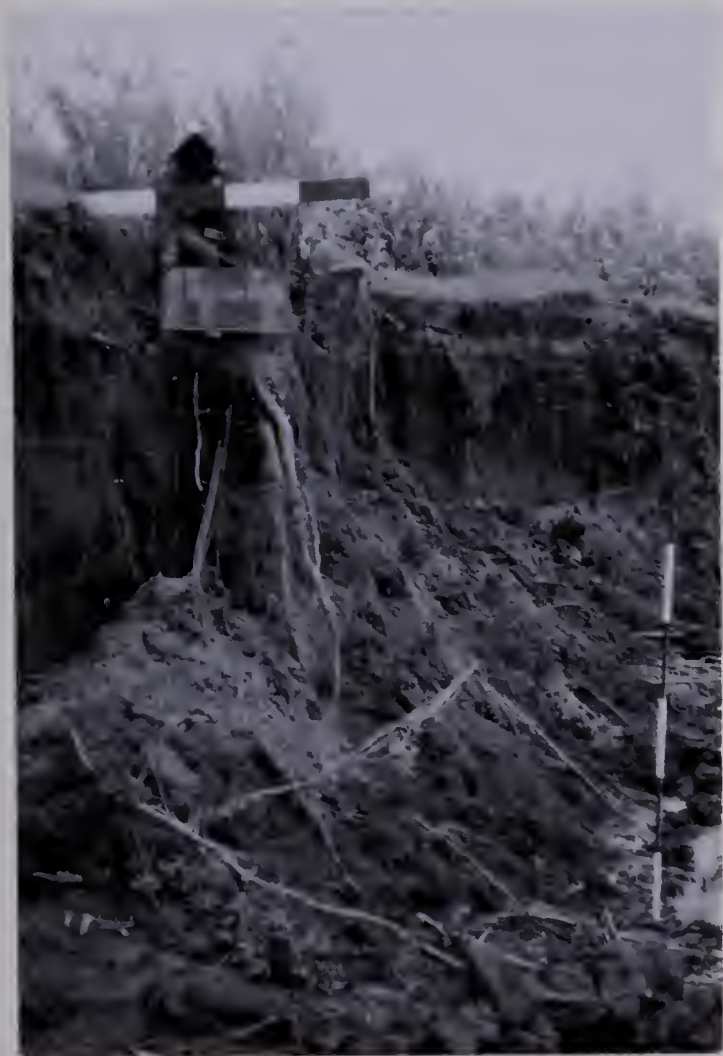
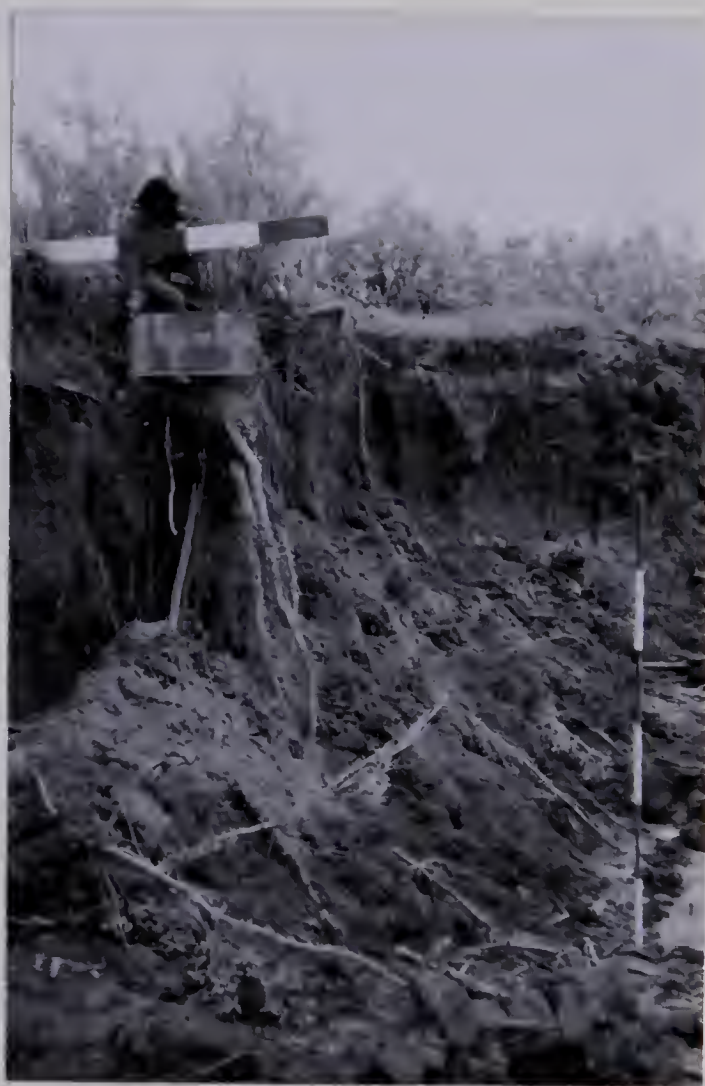
Plate 6 (In the pocket) A stereo pair taken at site G from which bank retreat was measured (see Figure 3). All scale markers have 0.5 m divisions.

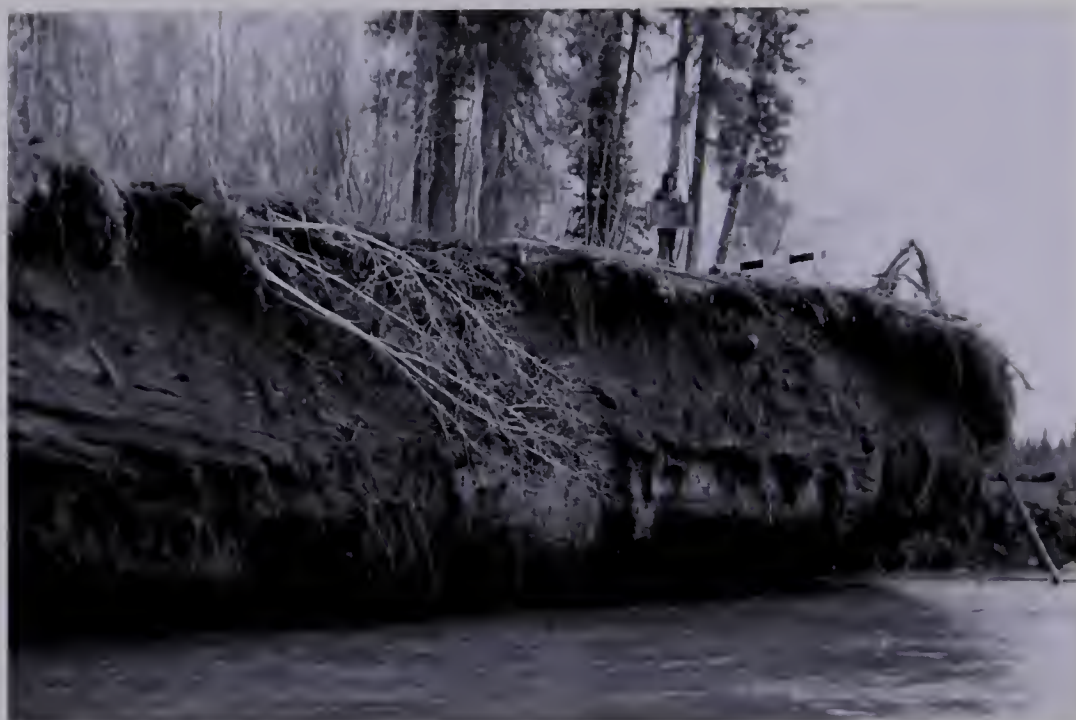
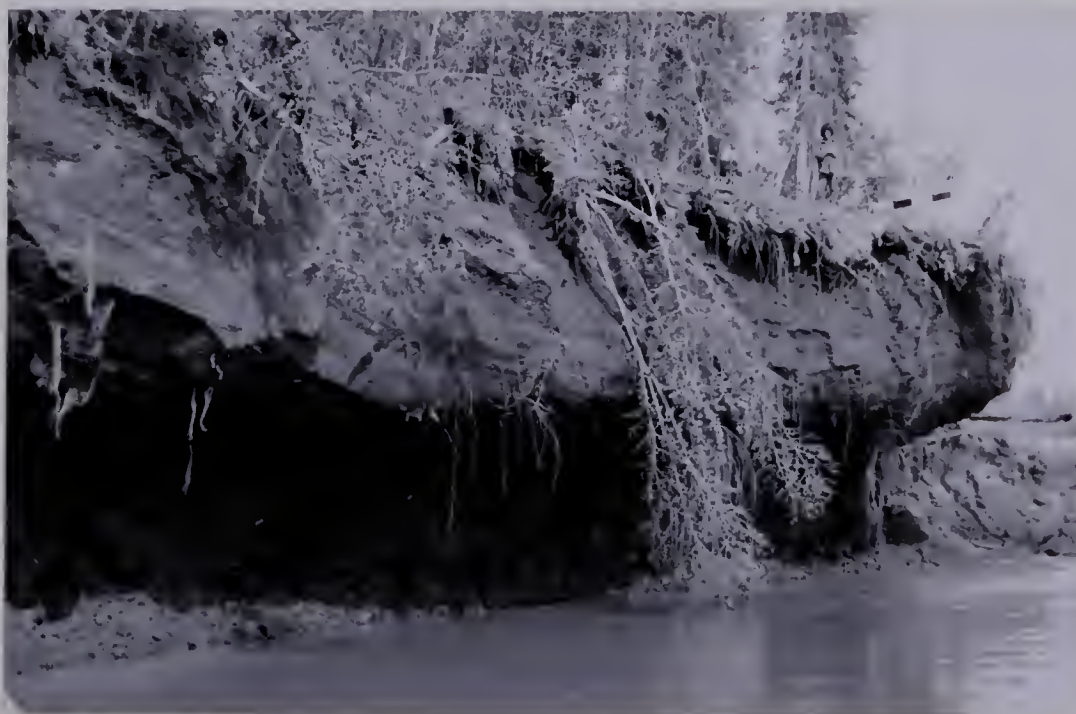
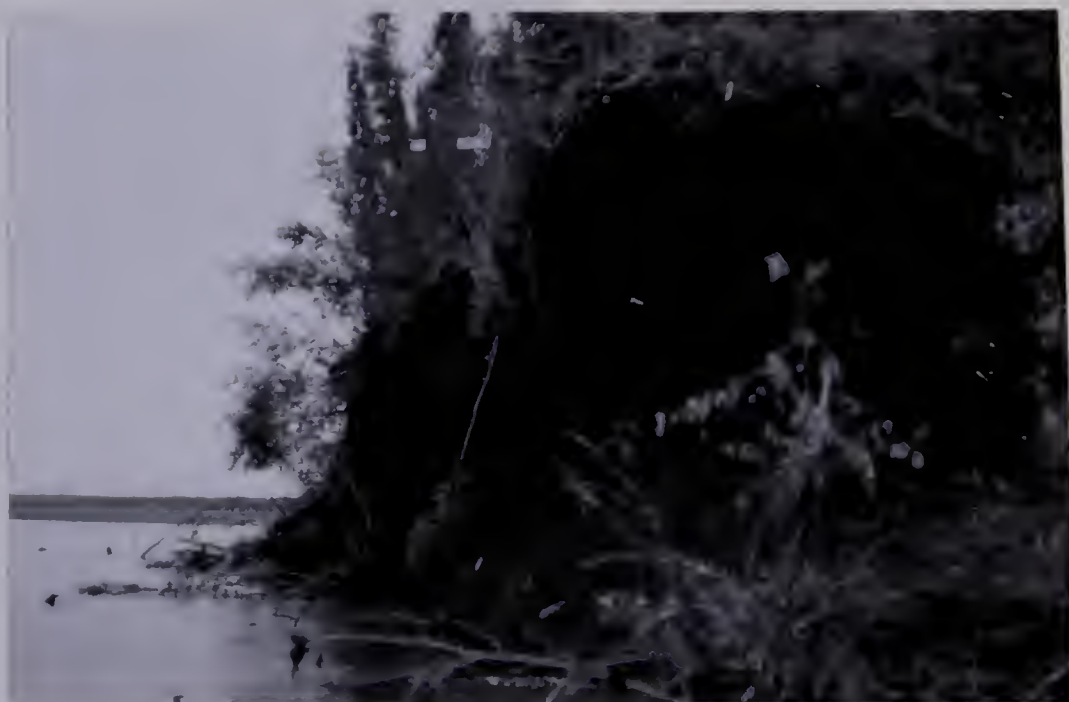
Plate 7 A bank with shape 1, at stage 1, within a few days of initial niche development (June 8, 1973).

Plate 8 The same bank as in Plate 7, at stage 2, 13 days later (June 21, 1973).

Plate 9 The same bank as in Plate 7, at stage 3, 40 days later (July 18, 1973).

The thermo-erosional niche was the most obvious effect of erosion observed in the study area. Niches in three different stages of destruction are shown in Plates 7 to 9. These stages are illustrated diagrammatically in Figure 4. A typical niche is initiated by a combination of efficient heat supply by the water along with current and wave action which remove insulative thawed material, penetrating the bank 3 to 5 m in less than 48 hours (Gill, 1972b). The roof of the niche then begins to thaw through exposure to heat transferred from the air and infra-red radiation from the water. Deposits of material (flowing or sloughing) accumulate on the niche floor to build up a small accumulation slope (stage 2). Approximately a month after the niche is initiated, it has been completely destroyed, leaving a large accumulation slope and a minor overhang (stage 3). If current velocity or wave action increases, the accumulation slope may be flushed away and a new niche initiated. All thermo-erosional niches develop in frozen bank material at locations of current velocity in excess of 30 cm/sec. Niches are much deeper in ice-rich sediment than in sediment without visible ice layers (approximately 10 m vs 5 m).

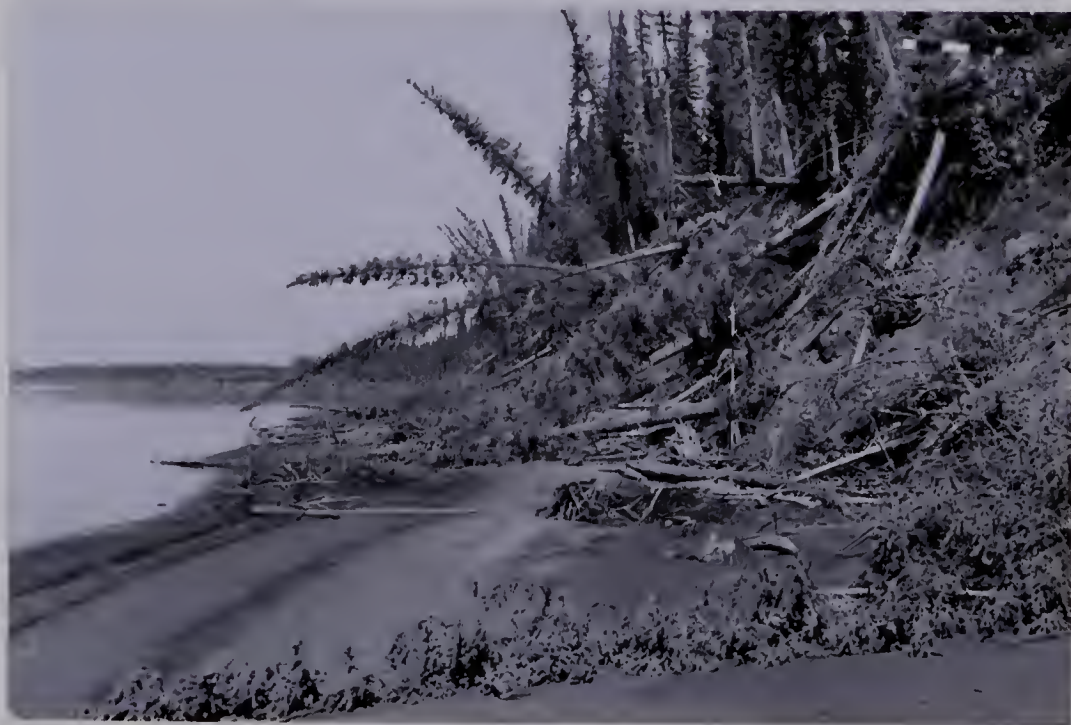
Plate 12 A bank with shape 4 (site L).

Plate 12 illustrates bank shape 4 and the beach associated with this shape. Plate 25 is a closer view of the waterline at one of these beaches. Beaches are found at all sites that do not have any measurable current velocity during the summer. These sites have a location on a channel orientated to the prevailing wind with a long open-water fetch in a NNW direction.

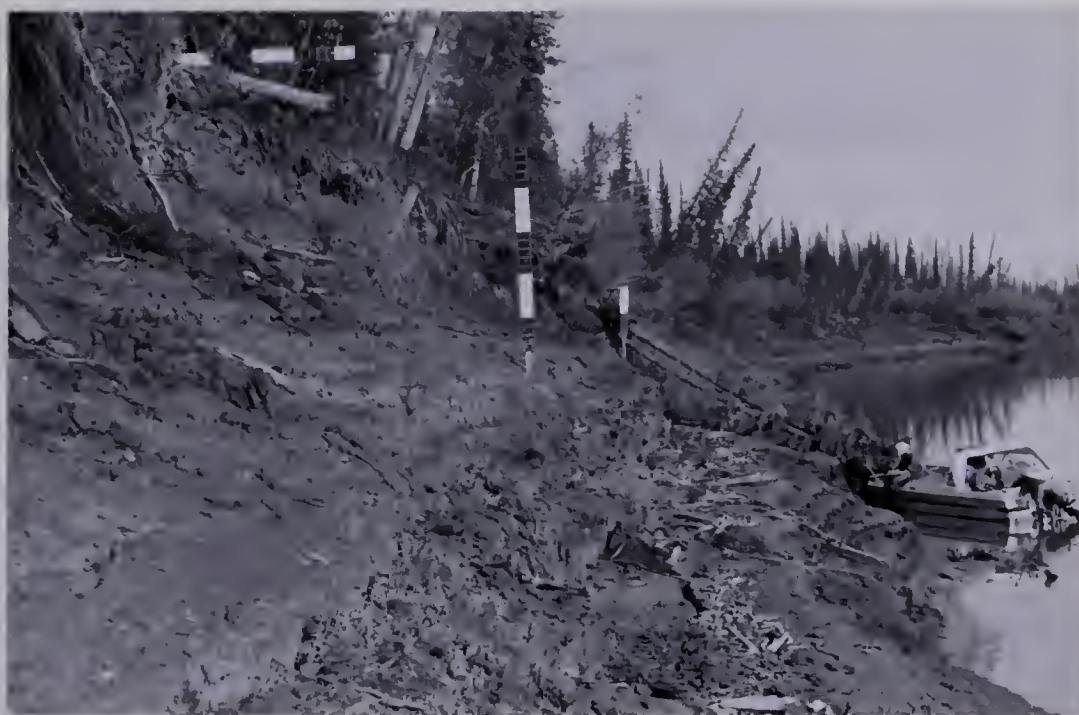
Plate 13 A bank with shape 5 (site 0).

Plate 13 illustrates strandline erosion steps as they appear on the lower part of a shape 5 bank as observed while standing on the bank slope. The features can be described

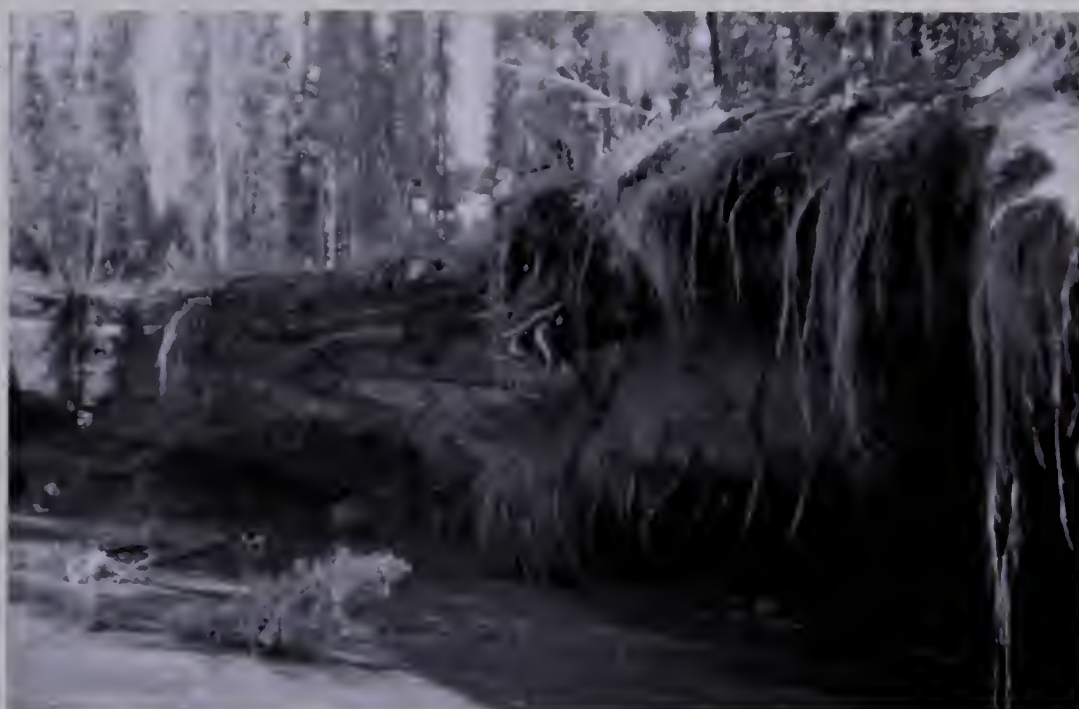
Plate 14 Roots retarding the perturbation of a niche roof (center of photo).

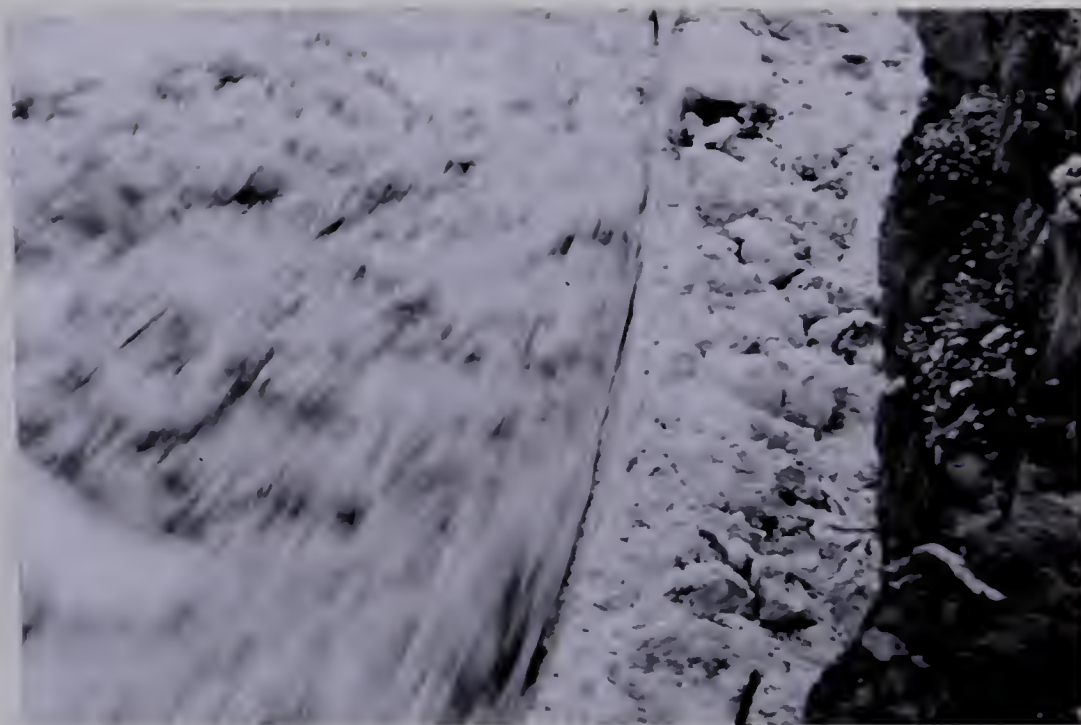
Plate 15 Break - up. Moving ice on the left is separated from bank - protecting stationary ice on the right by a shear line.

1. Except for south-facing banks, most banks are frozen at the time of break-up.
2. Delta ice "candles" at break-up. Melting of crystal boundaries forms individual "candles" that normally range 1 m in length and 5 cm in diameter. This weak, broken ice builds up along cut-banks, protecting them. A shear line separates moving and stationary ice (Plate 15).

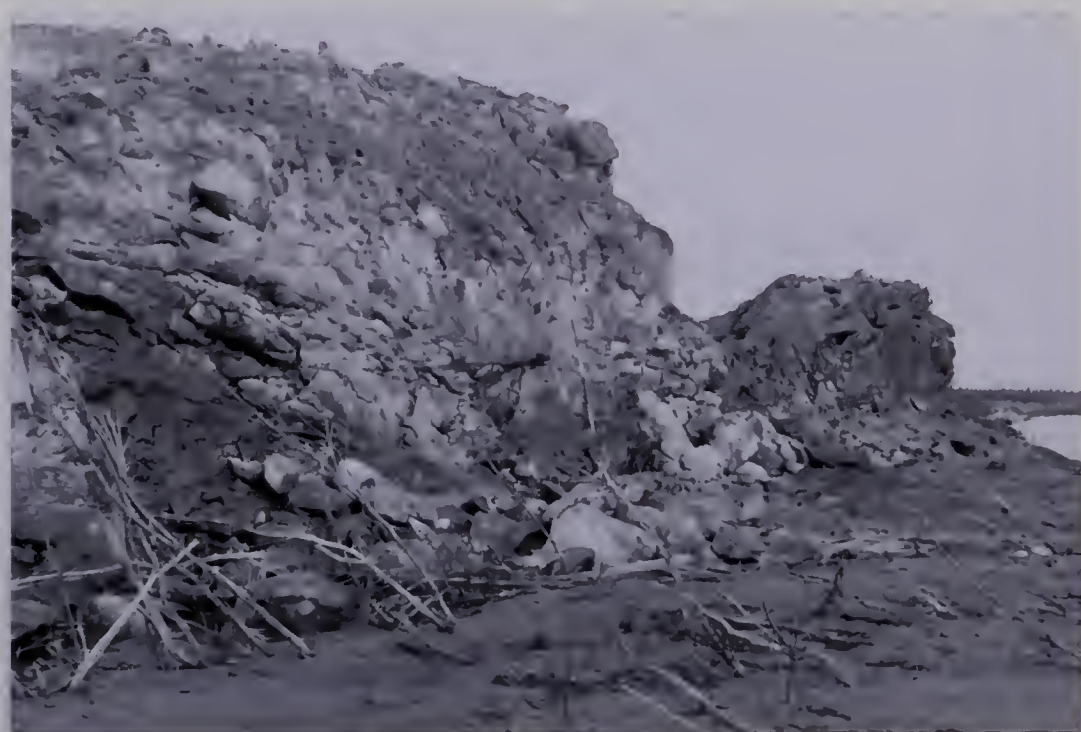
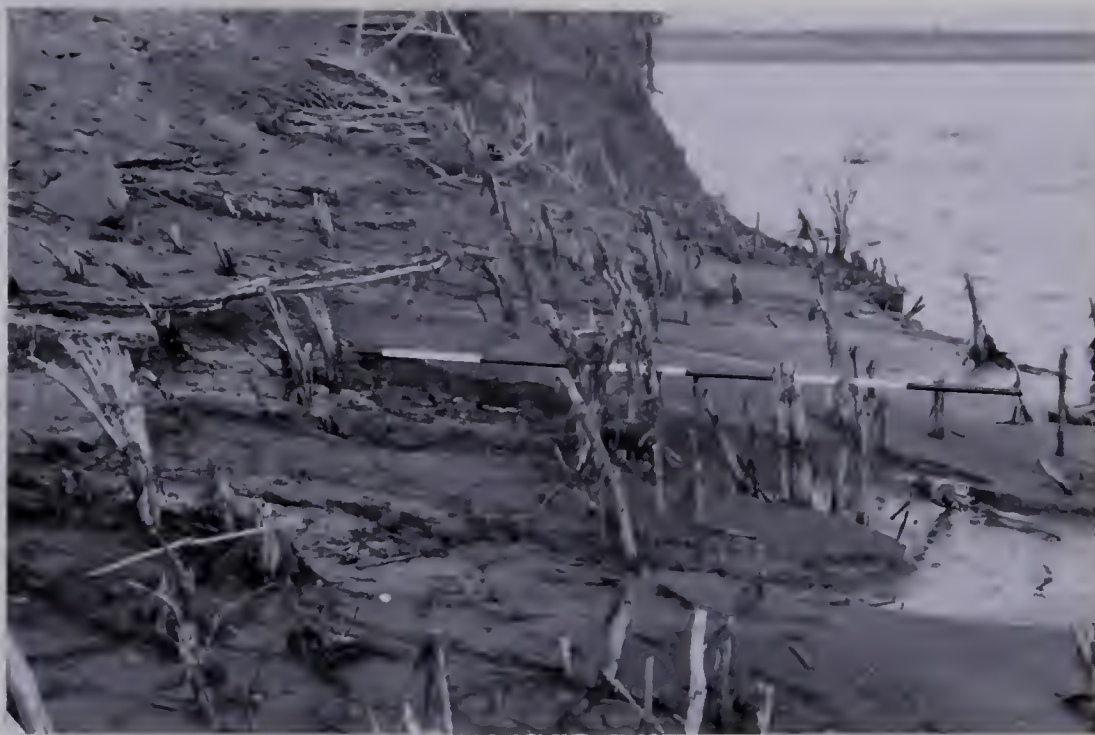
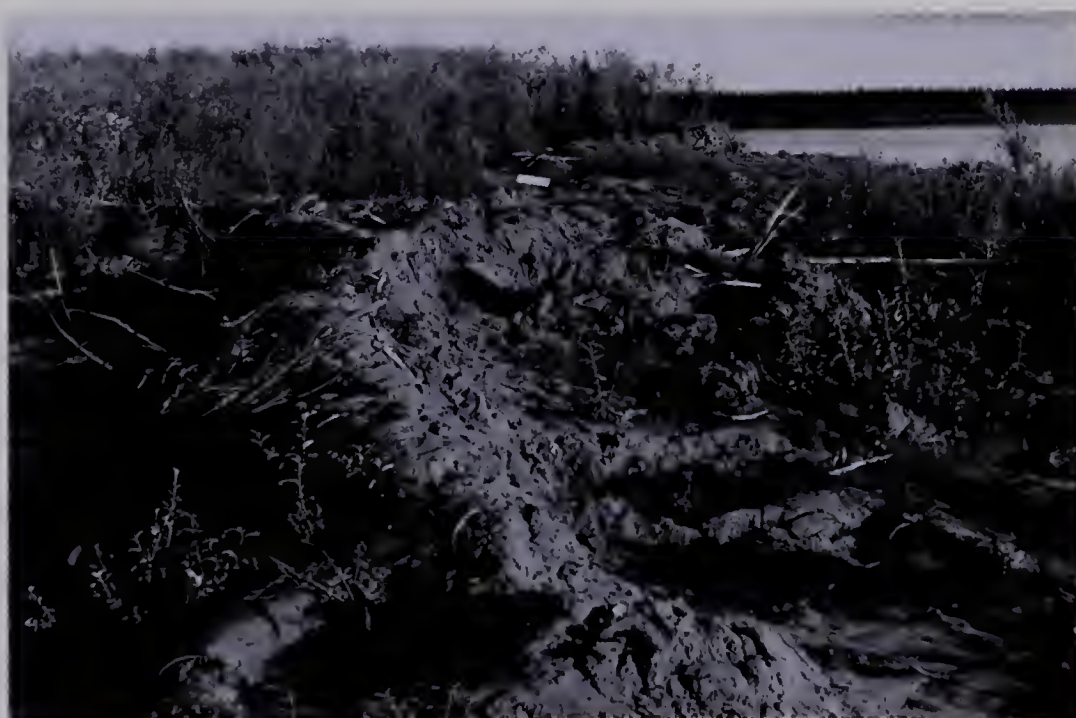
Plate 16 Massive Mackenzie River ice pushed onto a bank at the junction of East and Middle Channels.

Plate 17 Willow stems broken by the ice pushed up in Plate 16.

Plate 18 Ridges of alluvium formed by the ice shown in Plate 16.

Massive Mackenzie River ice not weakened by candling tends to ride up over the tops of banks (Plate 16) at sharp bends or channel divisions causing broken stems of willow (Plate 17) and small ice-pushed ridges (Plate 18) in places where some of the bank material has thawed. These features were also described by Gill (1972b).

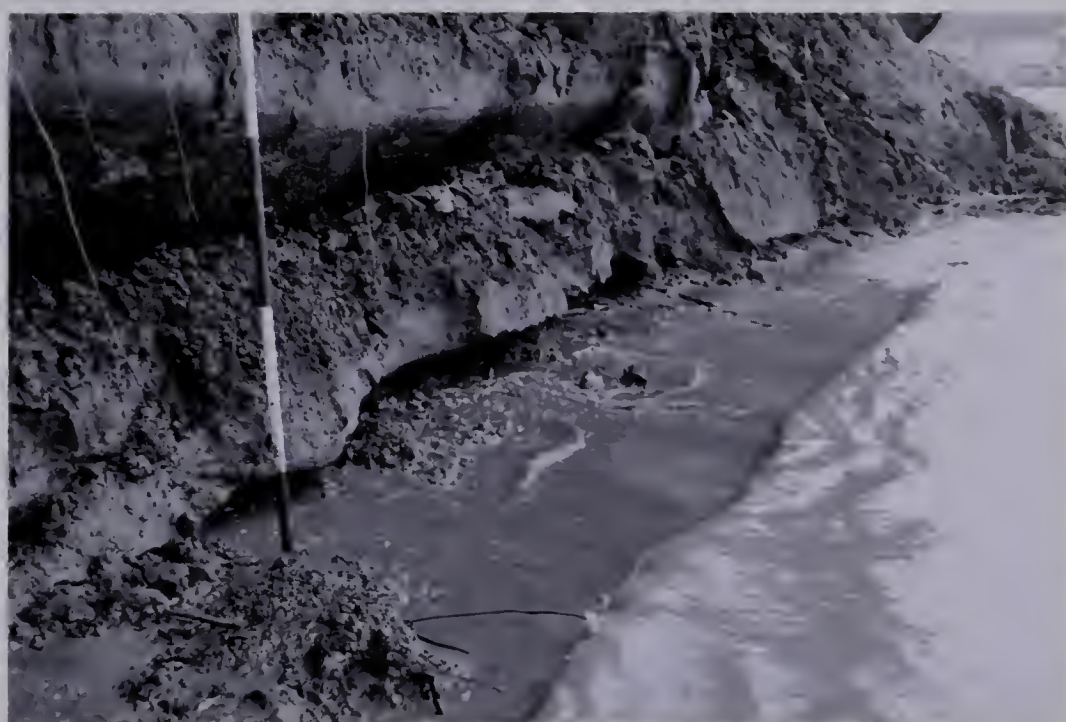
Plate 19 A wave - eroded niche at site H.

material at locations with moderate average summer current velocity and high wave action. A wave-eroded niche is shown in Plate 19. There is a niche at a higher level than the one being eroded at the time of photography.

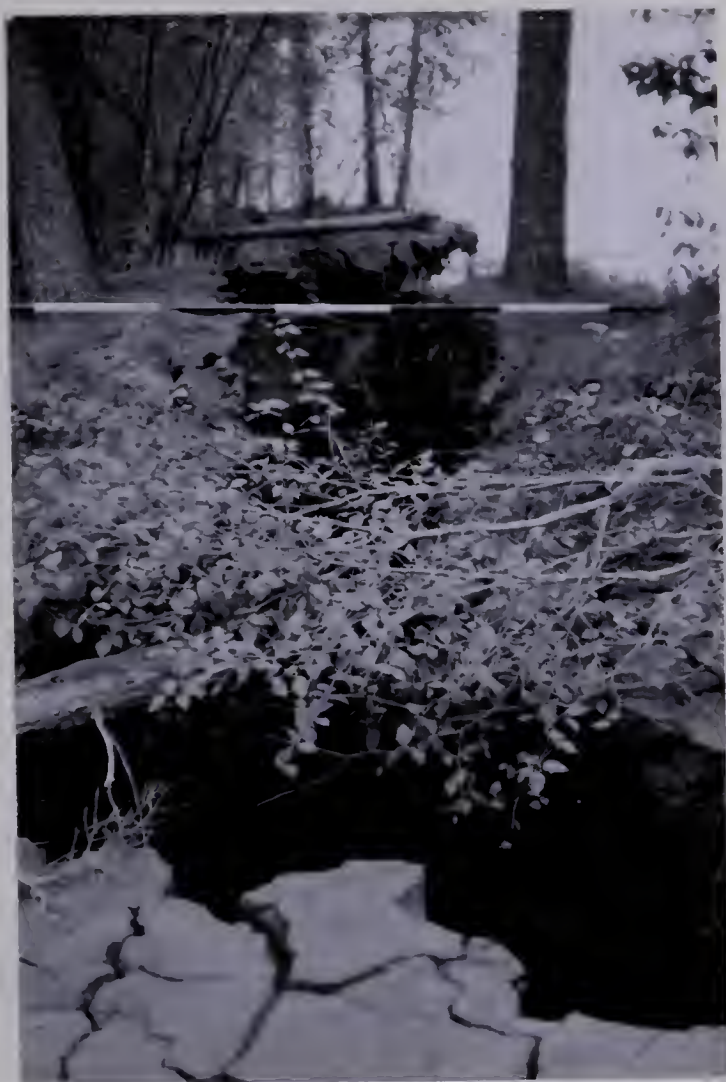
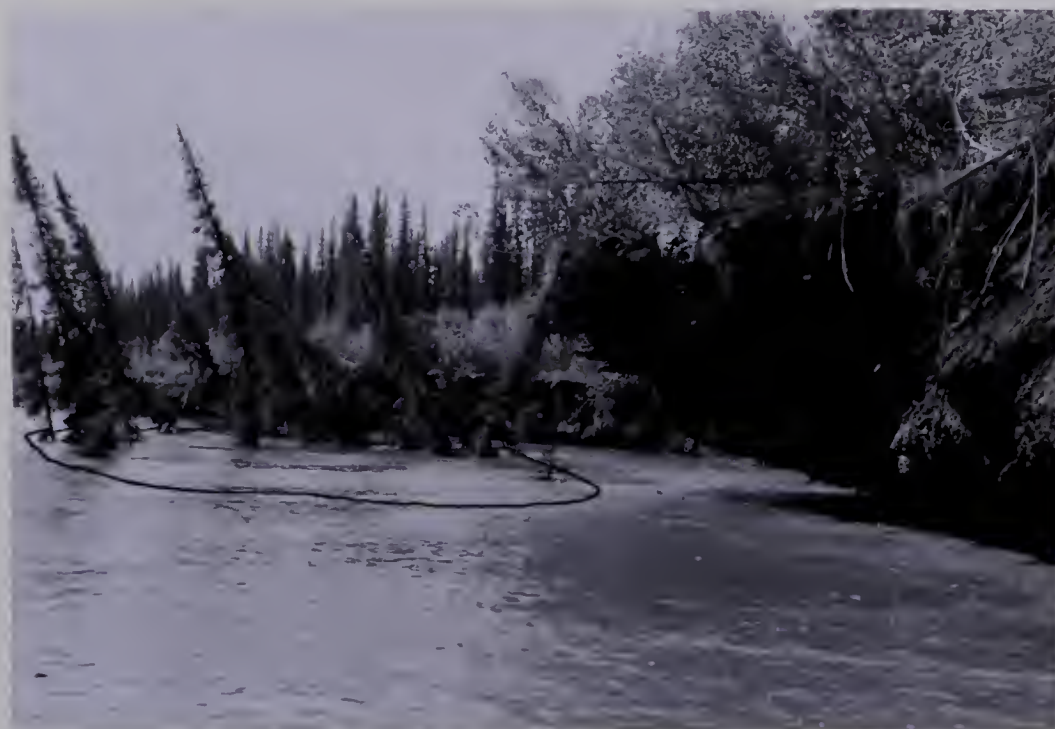
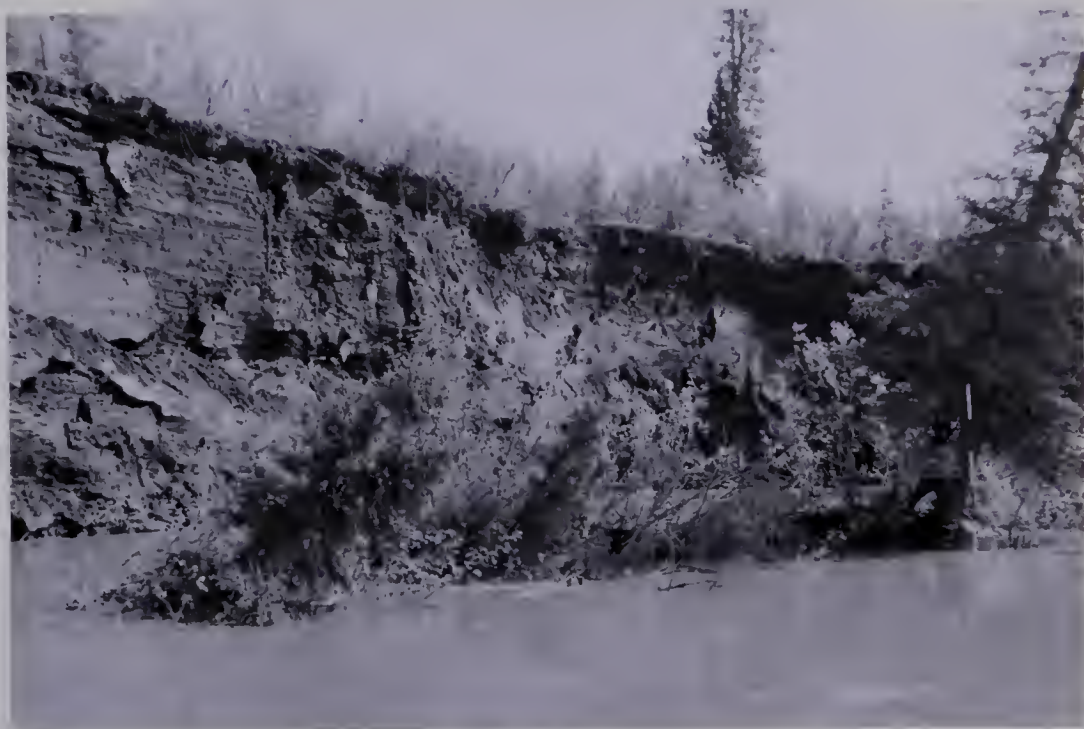
Plate 20 A tension crack in the top of a bank with shape 1 (site A).

Plate 21 A block (outlined) that has fallen from a bank with shape 1 and ice-rich sediment.

Plate 22 The side of an ice wedge exposed by the breaking away of a block.

Plate 23 A small block fallen from a bank (site F) with shape 2 and low ice content sediment.

Tension cracks, fallen blocks, and ice wedges are associated with sites where deep niches have developed in ice-rich sediment (shape 1). Before a block falls from a bank undermined by a niche, a tension crack appears in the levee surface (Plate 20). After a block falls into the channel (Plate 21), the sides of ice wedges may be exposed (Plate 22) in the former location of the tension crack. This will happen where ice wedges are common and if one is orientated parallel to the bank in a tension zone. The ice wedge, being a plane of vertical weakness, will be exposed upon breakage of the bank. This process has also been observed by Walker and Arnborg (1966). Ice wedges only appear at sites where ice-rich sediment is present. Generally, sizes of fallen blocks are much smaller at sites that do not have ice-rich sediment (Plate 23) because of shallower niches at such sites (section 4.4.1).

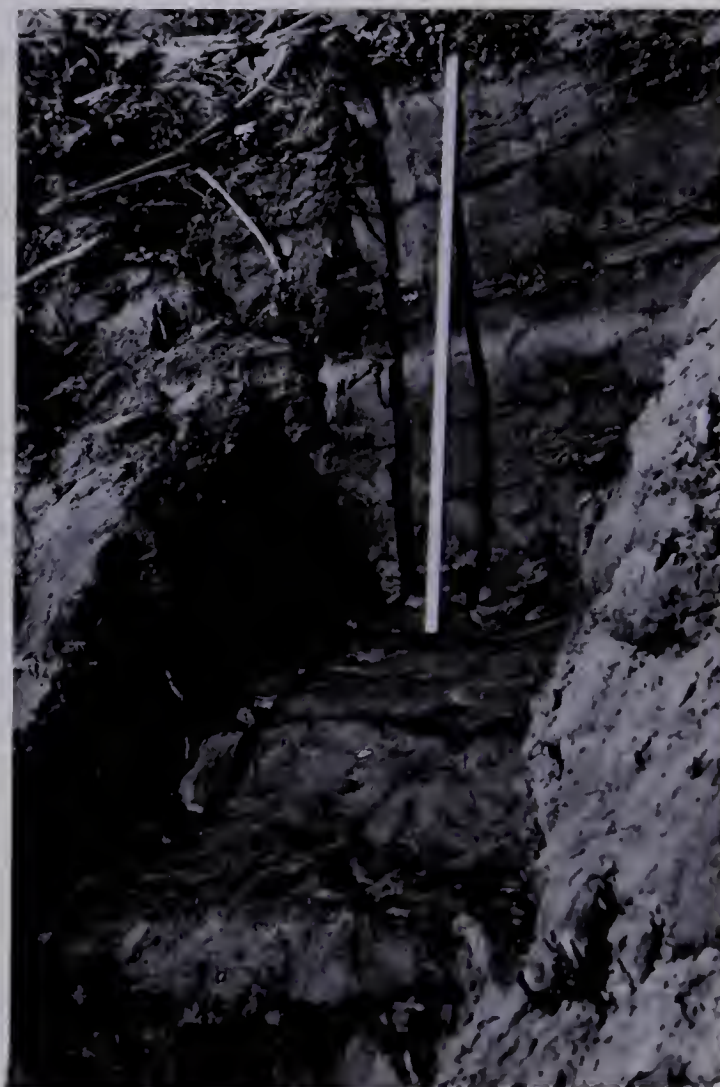
Plate 24 A pit dug to the surface of frozen material at a bank with shape 3. The stick is 1 m long.

Plate 24 shows an excavation on a shape 3 bank dug into the top of the slough slope where it met the thawing bank face. All unfrozen material was removed. It can be seen

that there is very little thawed material on the bank face and that the top of the frozen material beneath the slope parallels the surface. A similar situation was found at all other sites with slough slopes. A photograph resembling Plate 24 was published by Walker and McCloy (1969, frontispiece) indicating the similarity of bank erosion processes in other deltas.

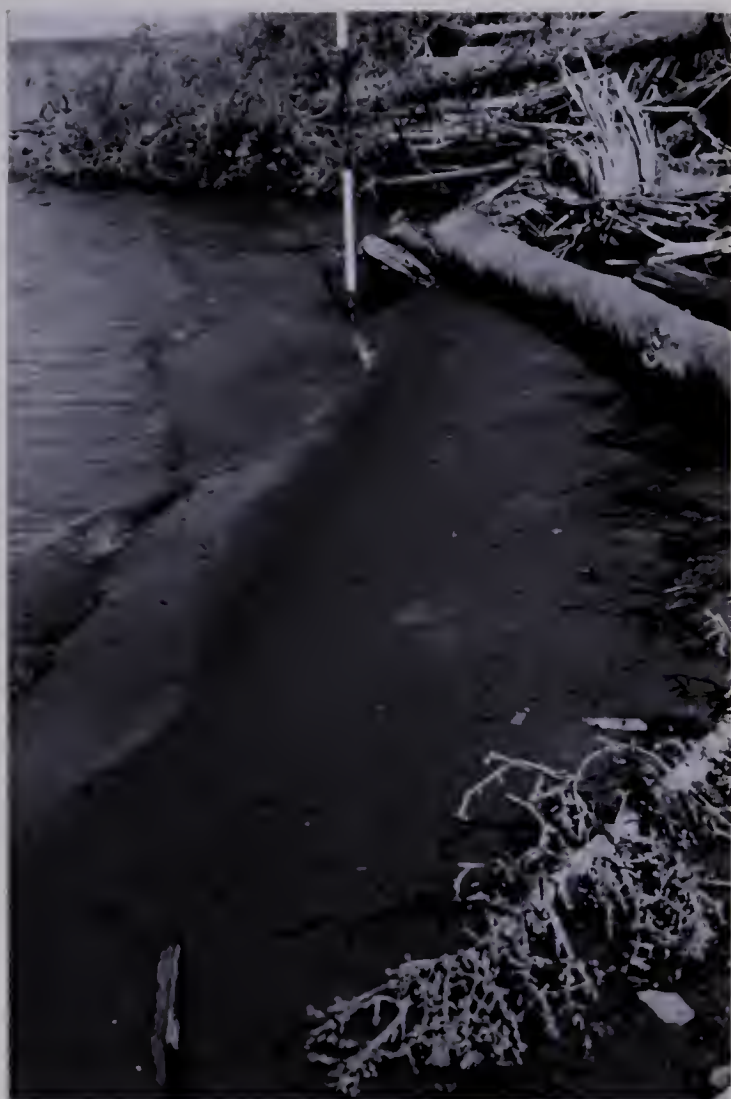
Plate 25 A close view of the beach shown in Plate 12.
